# HAZARDS OF HYDROGEN SULFIDE (H<sub>2</sub>S) FOR ELECTRICAL AND ELECTRONIC INSTALLATIONS

ENGR. MISRI KHAN KHOSO  
AGM (Electrical)

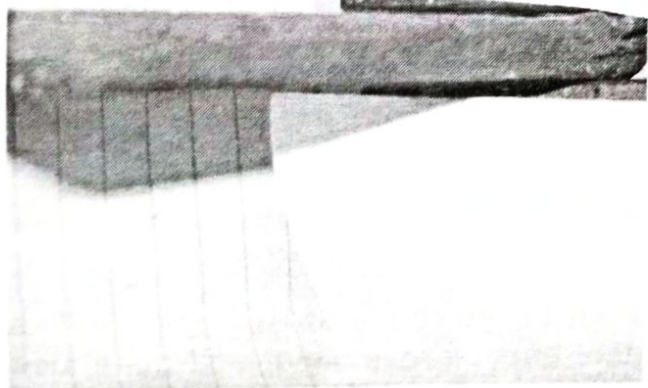
- ❖ The piece placed near the bio gas control room was found to be worst affected the portion of the copper but 25% area of tin coated was carbonized .

Copper piece placed at roof of biogas plant

- ❖ Bus Bars and other current carrying installation should be tin coated
- ❖ At the time of procurement must be explained your atmosphere and insist on supplier that they must provide anti-rust coated equipments

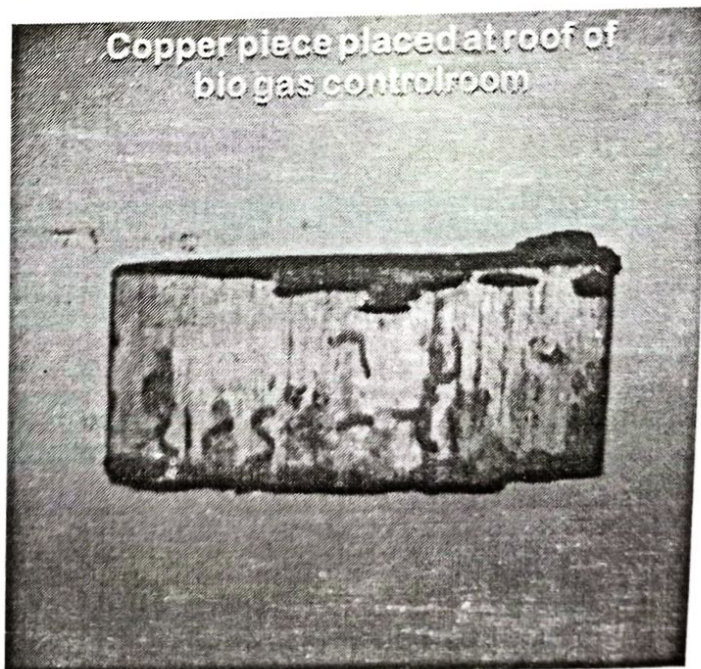
Copper piece placed at roof of bio gas control room

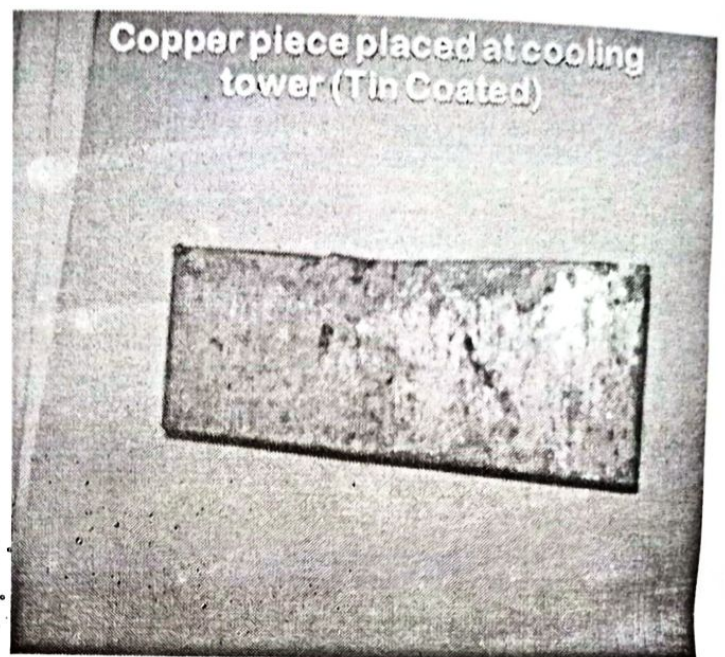
- ❖ Copper piece the portion of same bus bar placed at the roof of cooling tower control room in the way of untreated spent wash was also badly effected, Its tin coated portion was less effected

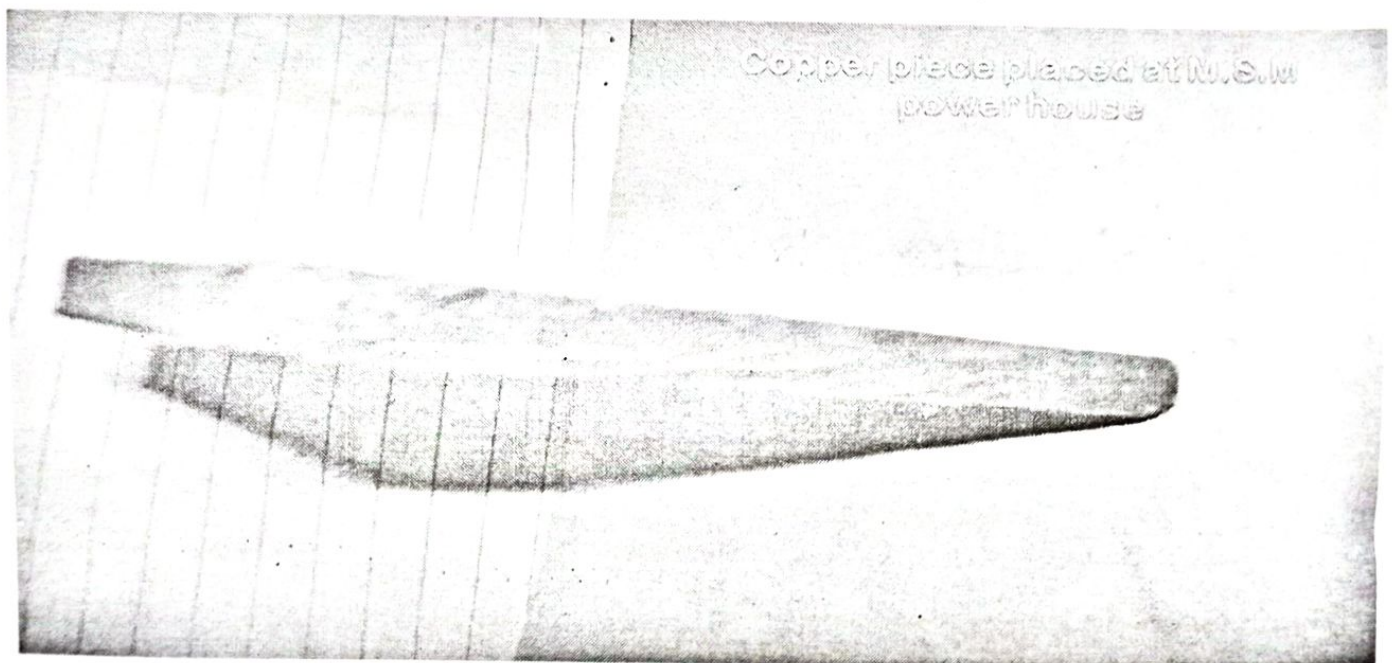
- ❖ Piece carried from the roof of M.S.M Power House.

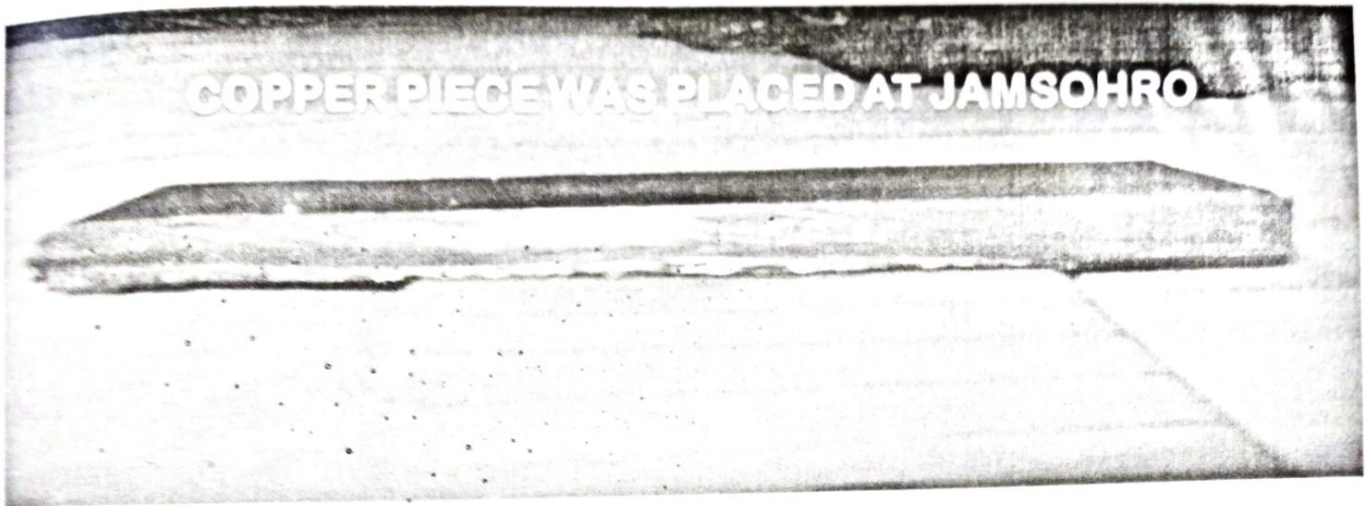
- ❖ The piece kept at Jamshoro which is out of the reach of Hydrogen Sulfide gases. Above pictures and study of this paper proved that self generated sulfide gases are unpleasant. In high concentrations. They can even be life threatening and dangerous for all installation which comes in its exposure and especially at the direction of wind from Bio gas. Pictures show that copper is easily effected due to corrosive action. Experience also shows that medium and low Voltage equipments easily fail due to carrions within no time especially controlling and dry contacts created high level disturbances in control system when supplied un proper signals.
